Water Resources Department

January 24th, 2017

Re: Wallowa Dam (W-2) – Inspection Summary

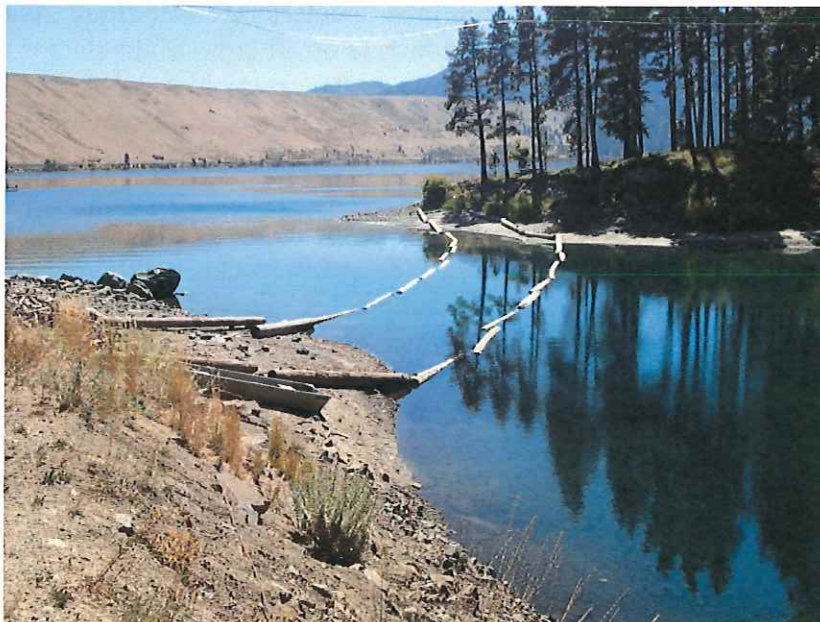
Log booms upstream of the dam

This reservoir has water surface elevation restricted at 4375 feet. However, similar to previous years, in June of 2016 the Associated Ditch Company was granted a temporary increase in the water level to 4377 feet. At the time of the inspection, the reservoir level was at an elevation of 4371.05 feet, based on the gage reading, nearly 4 feet below the restriction. At the time of the inspection, the reservoir was clear and contained no logs or other floating debris.

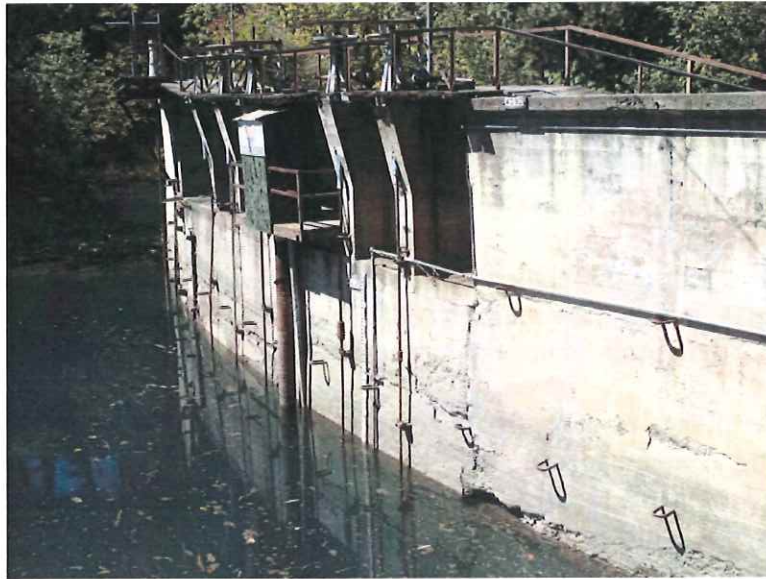
Upstream face showing deteriorating concrete

The dam and its appurtenant structures continue to deteriorate with time. As a result, the dam is near the end of its design life. The concrete on all areas of the dam is spalling and cracking. Of particular concern is the concrete on the upstream face. As noted in previous inspections, there is a band of concrete that is weak and easily removed when struck with a hammer.

In general, the concrete of the downstream side of the dam was in poor condition. Vegetation was observed growing on the surface and in cracks, but there was no noticeable seepage. Efflorescence was observed along cracks and joints. Concrete spalling was observed on the edges of the stepped buttresses and training walls. The abutments are located on glacial moraine cobbles and boulders, and not on bedrock. As a result, there is some question as to the stability of the dam.

1. The dam needs to be rehabilitated or replaced very soon. The process for rehabilitation/replacement can be lengthy so the process should begin as soon as possible.
2. Re-attach the steel liners in the outlet tunnels.
3. The gates for the outlet tunnels will most likely not last that much longer. If these fail, you will lose the ability to store water. As a result, these will need to be replaced in the near future.
4. Until rehabilitation/replacement, continue to operate this dam as per the restriction we have previously established and continue to enforce.

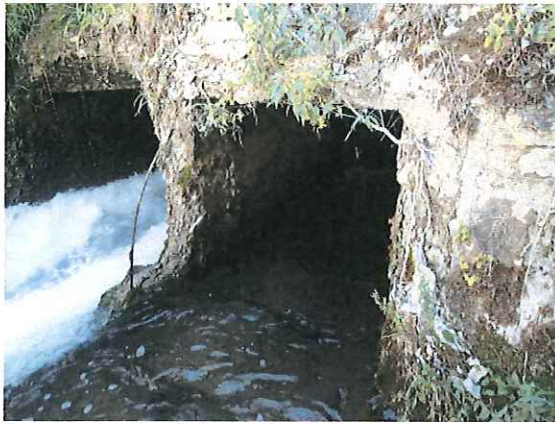
Gate tunnels 5 (open) and 4 (closed)

There are five gates that control the flow to each of the five outlet tunnels. The gates are manually operated frequently. The conduit tunnels experience continued deterioration, delamination and spalling, and calcium carbonate efflorescence (spires) from seepage. As was the case in past inspections, the gates cannot be completely closed and leak significantly. During the inspection, the operator closed the gate valves as much as possible so that we could observe the amount of leakage from the gates. The gates are numbered consecutively starting from the left abutment. Gates 1, 3, and 5 leak when closed, while Gates 2 and 4 do not. The leakage, in cubic feet per second (cfs), through gates 1, 3, and 5 was estimated at 20 cfs, 14 cfs, and 6 cfs, respectively. At some point in the near future the leakage will prevent effective storage of water.

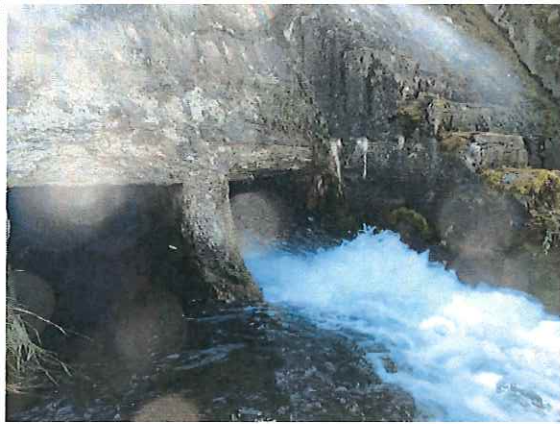
Gate tunnels 2 and 1 (both closed)

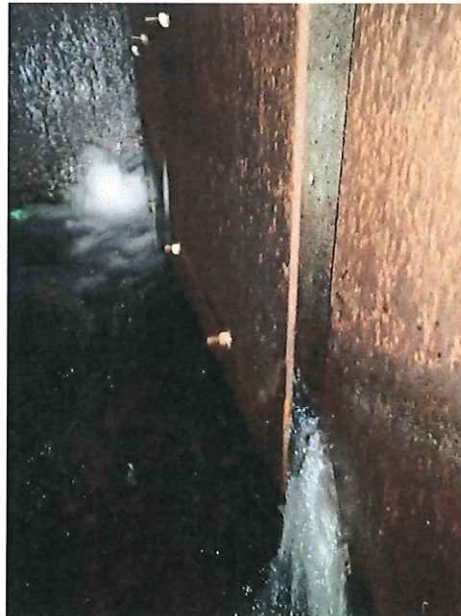
Steel plate in tunnel separating from the concrete

In addition, the steel liners that were installed approximately 20 years ago, as temporary measures, are now detaching in gate tunnels 2 and 4. Due to the leaks in tunnels 1, 3, and 5, it was not possible to determine if the liner is separating in these tunnels. However, it is likely that the liner has begun to separate because the liners in both tunnels 2 and 4 are separating.

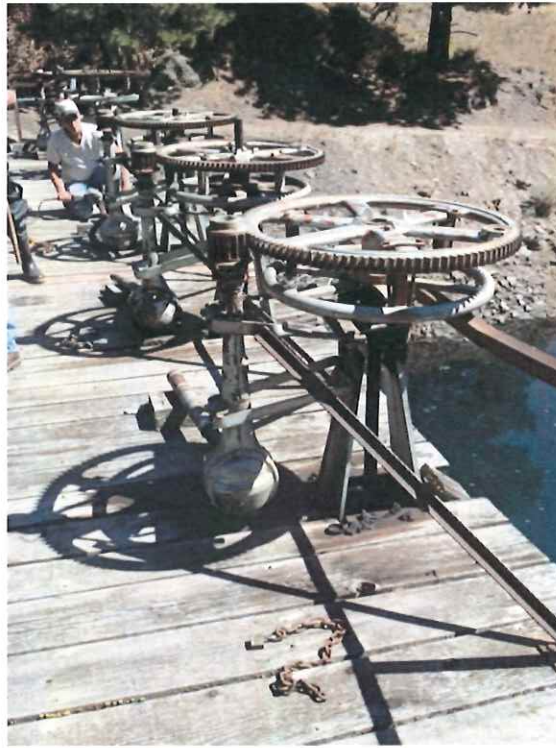
Control mechanisms for the gate valves

The control stems for most of the gate valves are bent. At the time of this inspection, the gate frames and gates themselves were still submerged and therefore not inspected. Prior inspections have noted continued deterioration of the gates and gate frames.
